8.3 Tips and Tricks: Fracture of a Ceramic Insert with modern Ceramic Total Hip Replacement

B.-W. Min, K.-S. Song, C.-H. Kang, K.-J. Lee, K.-C. Bae, C.-H. Cho and Y.-Y. Won

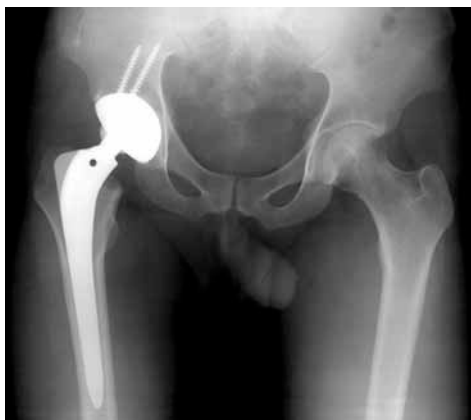
Figure 1a:

An anteroposterior radiograph of the pelvis of the patient in case 1, taken 4 weeks after surgery, shows a well-fixed cup and stem.

A 34-year-old, 67-kg man who was 164 cm tall and who had advanced osteonecrosis of the right femoral head underwent primary THA in March 2003. A transgluteal approach was used to place a ceramic-on-ceramic bearing implant (system I). The acetabular cup had a 52-mm outer diameter and a machined interior that accepted a ceramic insert (BIOLOX Forte). The metallic shell was not recessed, so that it would protect the rim of the ceramic liner. The femoral stem was cementless with a proximal porous coating (BiCONTACT). A 28-mm short BIOLOX (-3.5 mm) head was used. The cup abduction angle was 39°, and the anteversion angle was 22° (Fig. 1a). The hip was confirmed to be stable, with no neck impingement in any direction, during surgery.

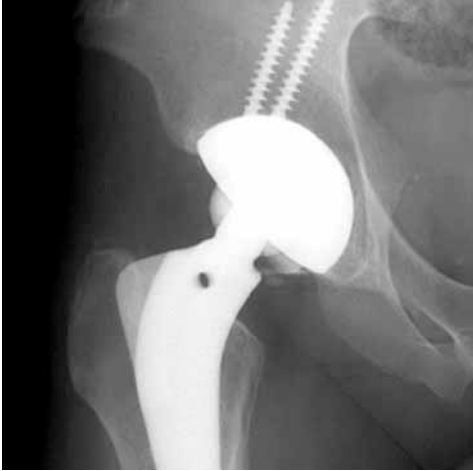
Figure 1b:

An anteroposterior radiograph of the right hip of the patient in case 1, taken 1 year 2 months after surgery, shows a comminuted fracture of the ceramic liner with fragments around the stem neck.

Postoperative progress was uneventful. Fourteen months after surgery, the patient felt crepitation without pain during hip motion. There was no history of trauma. A radiograph of the pelvis showed a comminuted fracture of the ceramic liner with fragments around the stem neck (Fig. 1b). The patient refused revision surgery. Seven months later, he felt pain, which was accompanied by increasing noise in the hip. Radiographs demonstrated increasing comminution of fragments of the ceramic liner, a well-fixed cup, and concentric placement of the ceramic head in the metal shell (Fig. 1c).

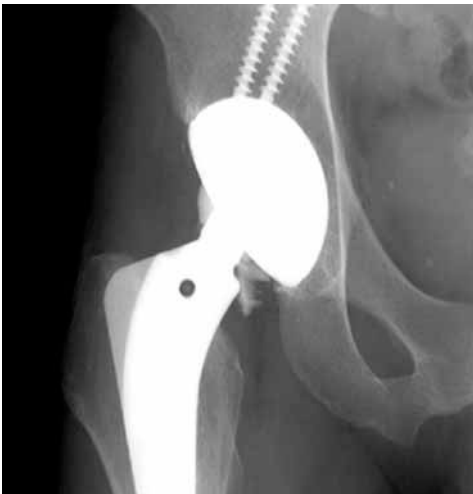
Figure 1c:

An anteroposterior radiograph of the right hip of the patient in case 1, taken 1 year 9 months later than Fig. 1b, demonstrates fragmentation and concentric placement of the ceramic ball within the metal shell.

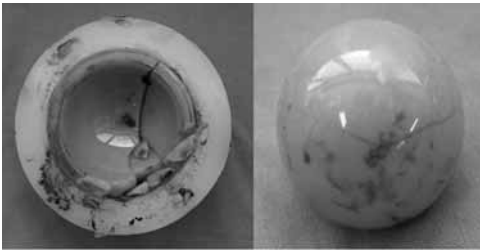
Figure 2b:

This intraoperative photograph taken during revision surgery on the patient in case 2 shows a severely fractured alumina insert and black discoloration of the ceramic head.

surgery (Fig. 2a). System IV was used for this patient. Findings during revision surgery showed that the alumina insert was severely fractured, and a black discoloration of the alumina head was observed, with loss of its surface gloss (Fig. 2b). However, there was no evidence of alumina head fracture or recognizable damage to the Morse taper of the well-fixed stem. After extensive débridement and synovectomy to remove as much of the ceramic debris as possible, a new alumina-on-ceramic bearing was implanted; the stem and cup were left in place (Fig. 2c).
